# **The Road Inventory of Minidoka National Wildlife Refuge Rupert, ID**

Prepared By:  
Federal Highway Administration  
Central Federal Lands Highway Division  
April 2013

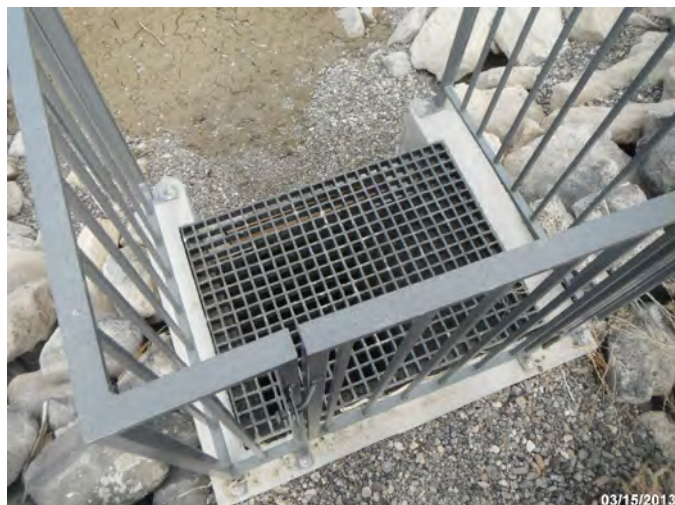
Photo: MINI\_C4\_0371 Route: 100-009-7.94  
Concrete WCS Flashboard Riser 40ft long 24in dia. 8ft deep  
8-002

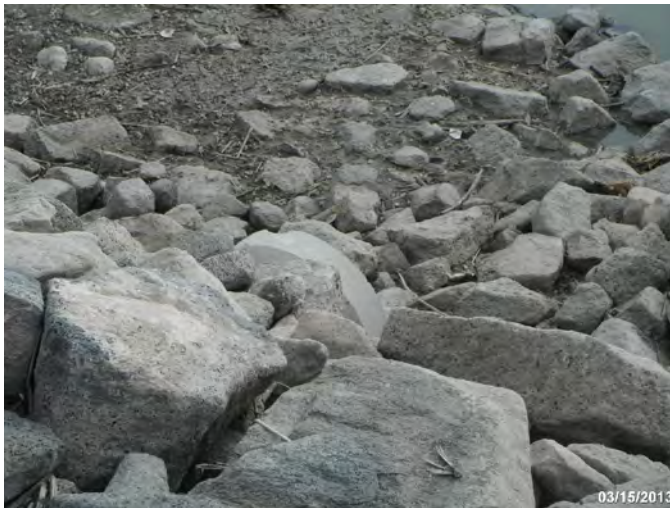
Photo: MINI\_C4\_0372 Route: 100-009-7.94  
Concrete WCS Flashboard Riser 40ft long 24in dia. 8ft deep

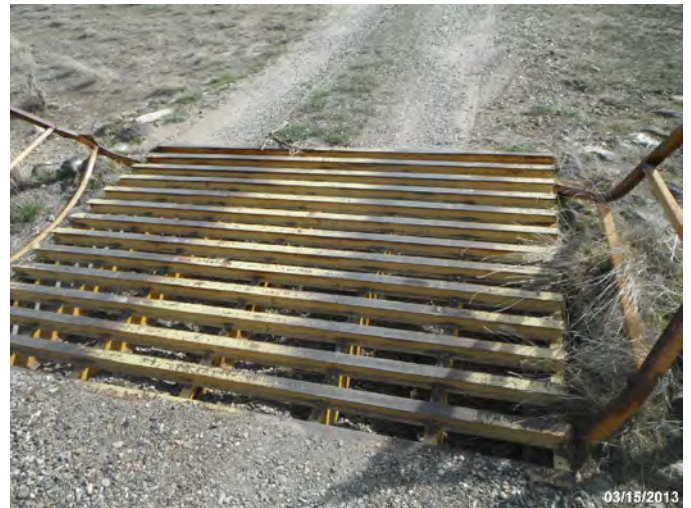
Photo: MINI\_C4\_0384 Route: 103-001-0.55  
Metal Cattle Guard

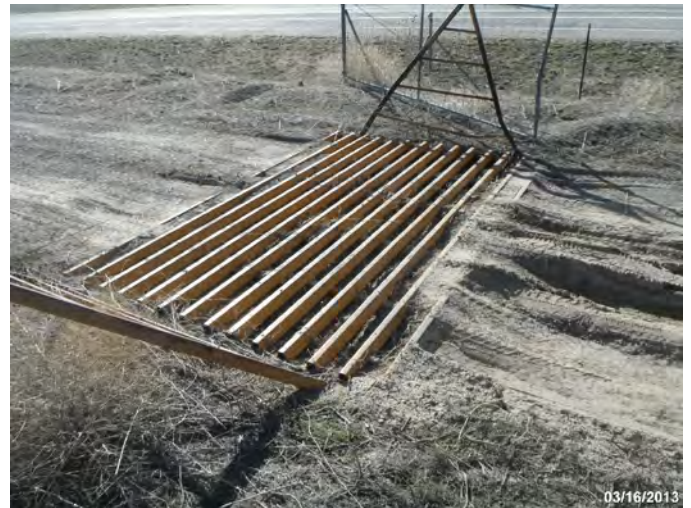
Photo: MINI\_C4\_0396 Route: 104-001-0.0  
Metal Cattle Guard

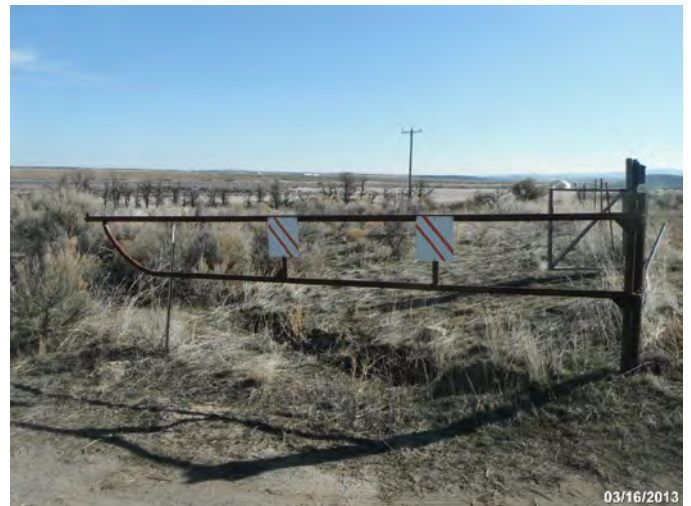
Photo: MINI\_C4\_0397 Route: 104-002-0.39  
Metal Open Rail Gate

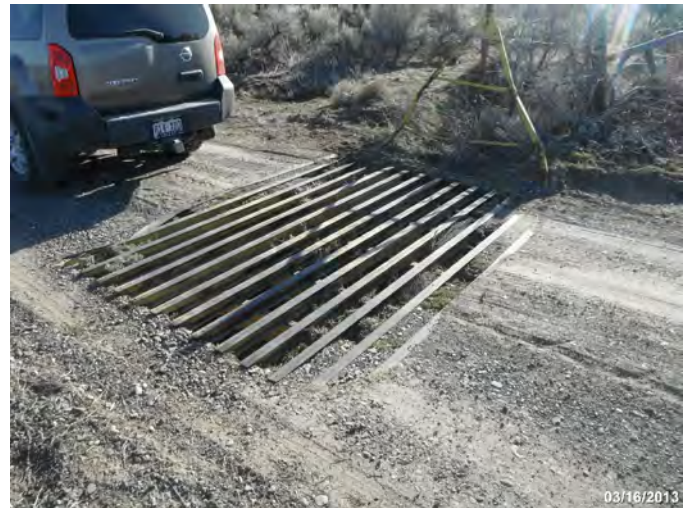
Photo: MINI\_C4\_0391 Route: 105-001-0.0  
Metal Cattle Guard

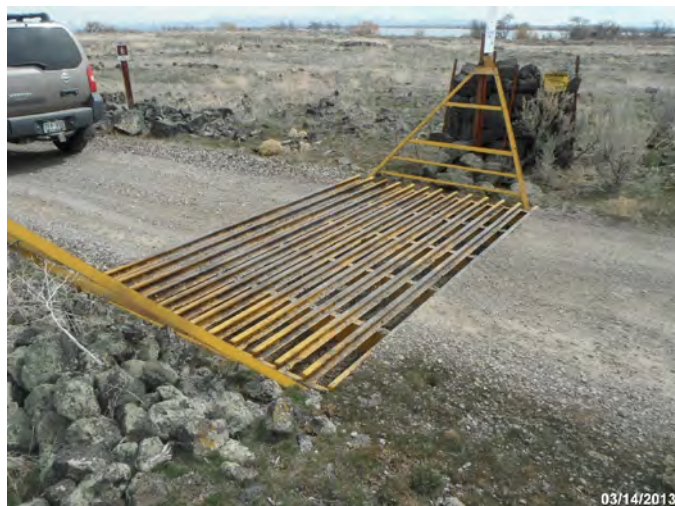
Photo: MINI\_C4\_0301 Route: 106-001-0.0  
Metal Cattle Guard

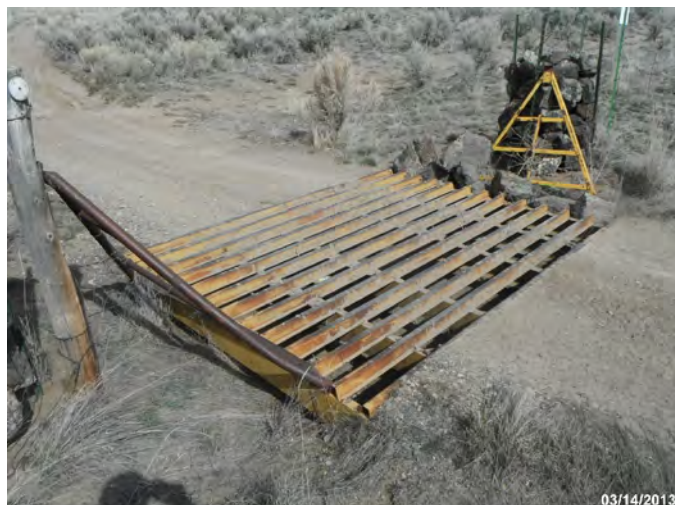
Photo: MINI\_C4\_0305 Route: 106-004-3.47  
Metal Cattle Guard

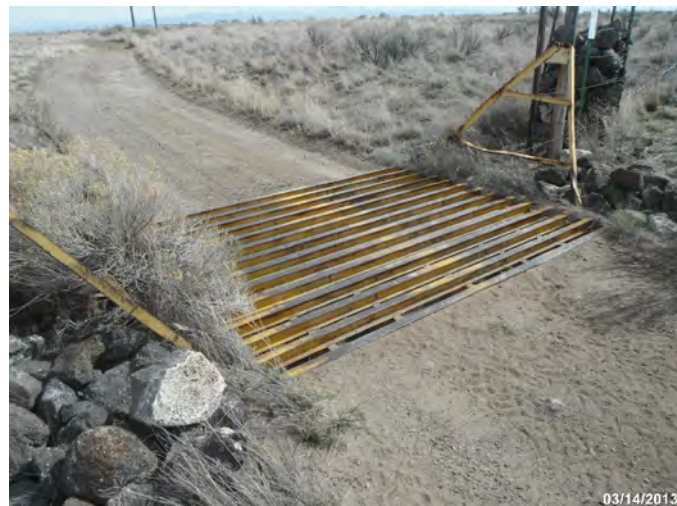
Photo: MINI\_C4\_0307 Route: 107-001-0.0  
Metal Cattle Guard

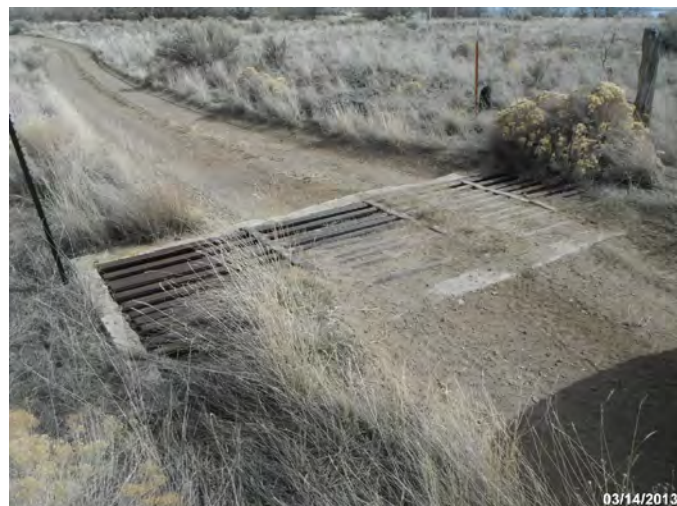
Photo: MINI\_C4\_0310 Route: 107-002-1.49  
Metal Cattle Guard

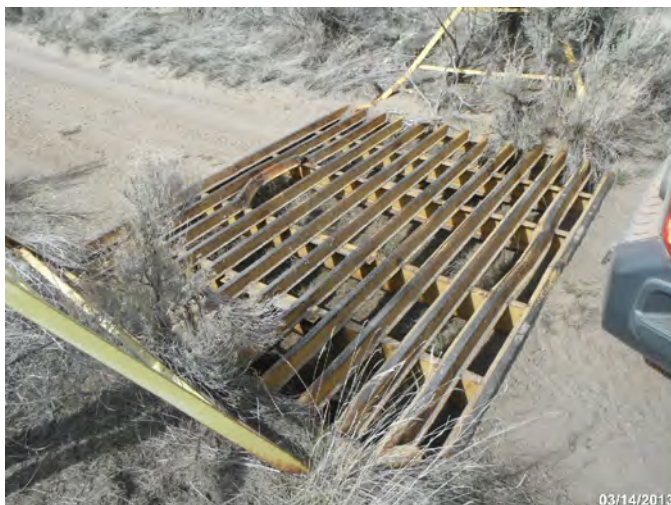
Photo: MINI\_C4\_0311 Route: 107-002-1.76  
Metal Cattle Guard

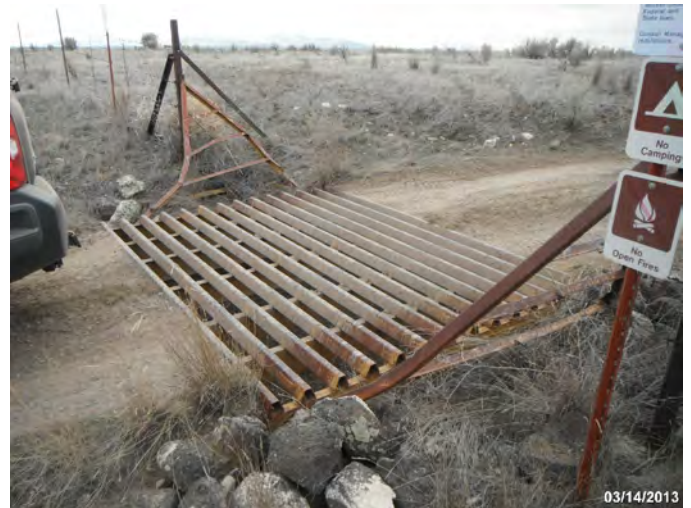
Photo: MINI\_C4\_0314 Route: 107-004-3.33  
Metal Cattle Guard

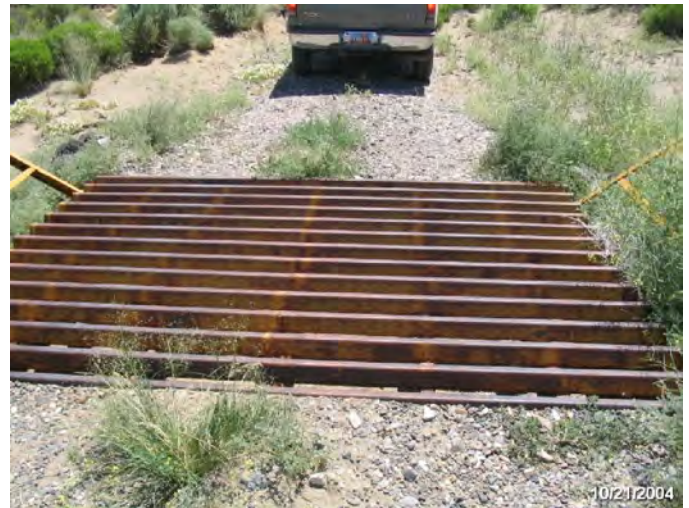
Photo: MINI\_C3\_0314 Route: 108-001-0.0  
Metal Cattle Guard

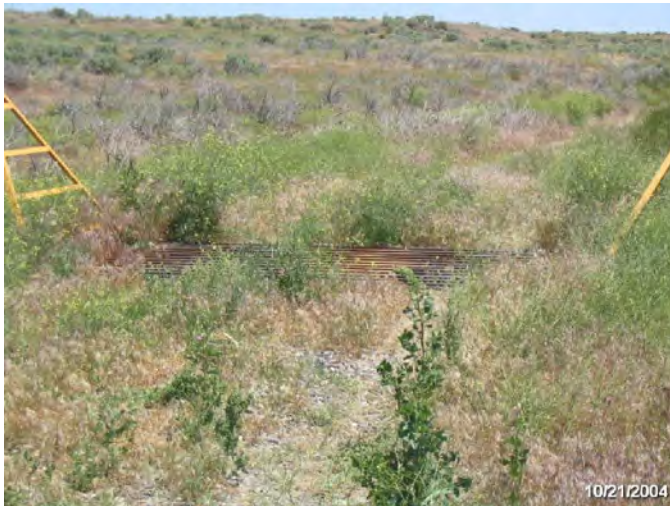
Photo: MINI\_C3\_0315 Route: 108-001-0.73  
Metal Cattle Guard

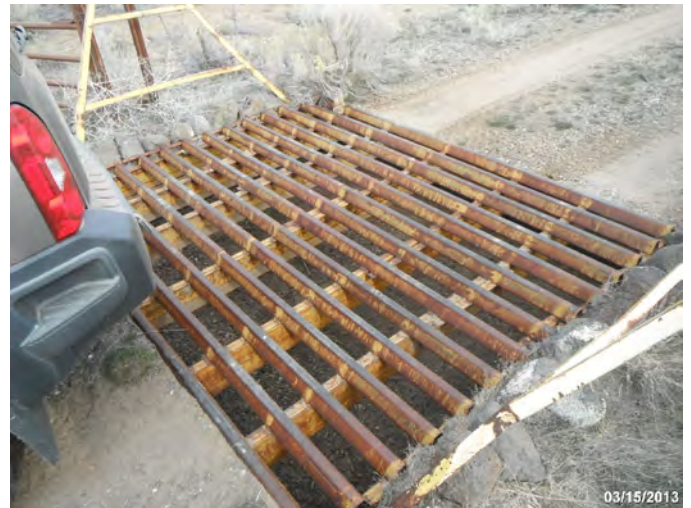
Photo: MINI\_C4\_0339 Route: 109-001-0.0  
Metal Cattle Guard

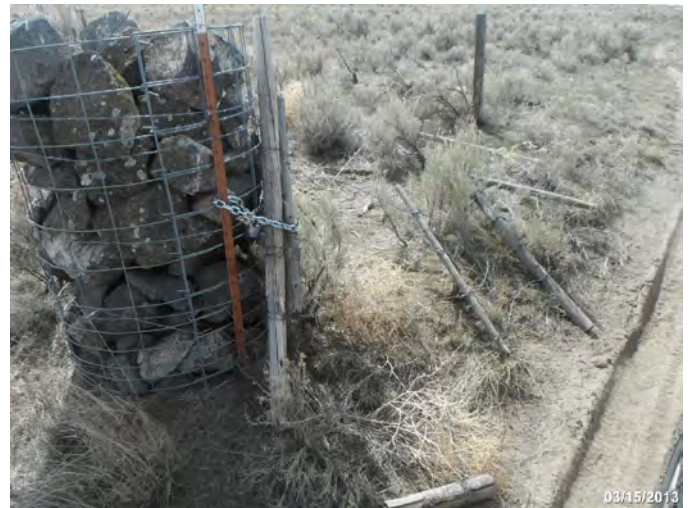
Photo: MINI\_C4\_0350 Route: 400-001-0.0  
Metal Cable Gate with Barbed Wire

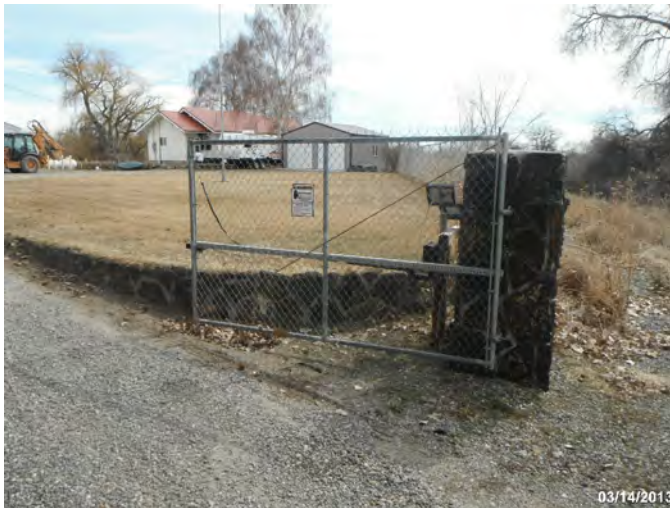
Photo: MINI\_C4\_0297 Route: 900  
Metal Chain Link Gate electric
